## **DIAGNOSTIC INVESTIGATIONS OF DIESEL ENGINE TURBOCHARGERS AT LABORATORY STANDS**

Tomasz Lus, Marek Łutowicz, Jarosław Listkowski

Polish Naval Academy, Mechanical – Electrical Faculty  
ul. Śmidowicza 69, 81-103 Gdynia, Poland  
e-mail: *t.lus@amw.gdynia.*; *m.lutowicz@amw.gdynia.pl*;  
*listkowski@amw.gdynia.pl*

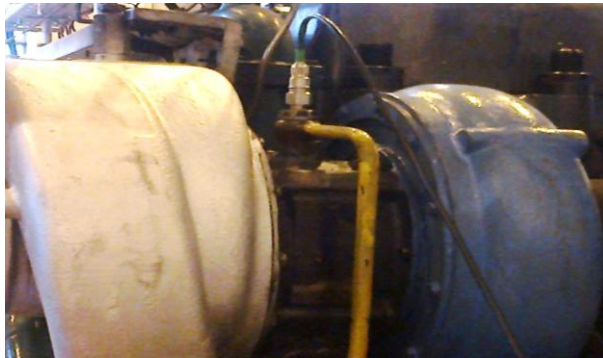
**Fig. 3.** Napier C-045/C type turbocharger with vibration sensor mounted on the bearing housing  
**3 pav.** Napier C-045/C tipo turbokompresorius su ant guolio korpuso sumontuotu vibracijos jutikliu

The objects of investigation were SULZER engine type 6AL20/24 with turbochargers installed in Polish Naval Academy laboratory [6] in Gdynia-Oksywie. The main data of the engine and turbocharger are presented in the table no 1. Measuring systems configuration and places where vibration sensors were installed are shown on figures number 2 and number 3.

Vibrations signals measured on bearing housing of the turbocharger are disturbed by engine crankshaft and pistons operation but there are reliable methods in vibration signal processing to separate these disturbances. Measuring the vibration signals one should have awareness how important is method of vibration sensor mounting on the tested machine. To present these phenomenon in the fig. 4 the acoustic signal spectrum of the turbocharger and its environment and for the same turbocharger in the fig. 5 vibration signal spectrum in frequency range from 0 kHz to 4 kHz are presented. The vibration sensor was mounted on the turbocharger casing by magnetic holder which was the reason to cut-off higher signal frequencies over 1,5 kHz – fig.5. In examples presented in the next paragraph vibration sensors were mounted on the turbocharger casing using screw holder. Other method which could be used in ship environment without losses in signal spectrum is method with glue mounted holders.

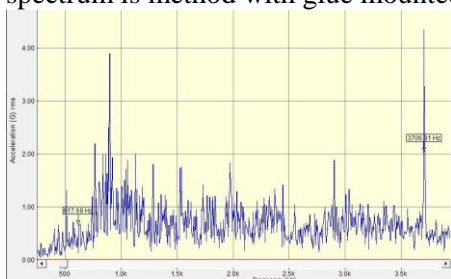
**Fig. 4.** Acoustic signal spectrum of the turbocharger in frequency range from 0 kHz to 4 kHz

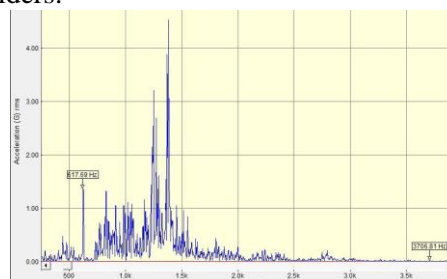
**Fig. 5.** Vibration signal spectrum of the turbocharger in frequency range from 0 kHz to 4 kHz – magnetic sensor holder

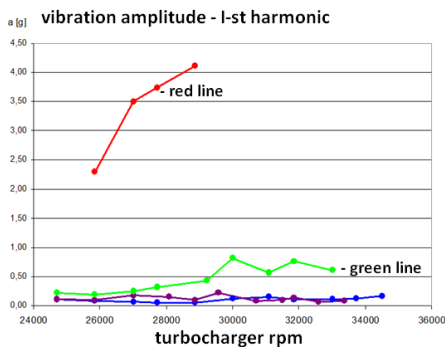
**Fig. 6.** Vibration acceleration amplitude of first harmonic for three turbochargers. Blue and violet line - turbochargers in good technical condition. Red and green lines – turbocharger in bad technical condition (red) and after repair (green)

Up to now more than twenty turbochargers type Napier C-045/C were tested on the same stand in Polish Naval Academy laboratory. If it was possible Sulzer engine type 6AL20/24 was loaded up to nominal output at nominal speed 750 rpm. In situations when technical conditions of tested turbochargers were very bad and carrying tests could endanger the engine and turbocharger operation tests were stopped and turbochargers send to workshop for repair. After repairs tests were carried out again. Vibration sensor was mounted on the turbocharger bearing housing using screw bolt as it seen in figure 3. Some chosen results from these tests are presented in this paragraph on figures from 6 to 12. In the figure no 6 tests results of three turbochargers is presented. At the axis of abscissae the turbocharger speed in rpm and at the axis of ordinates the value of vibration acceleration amplitude of first harmonic in [g] scale are presented.

Vibration acceleration amplitudes of I harmonic of two turbochargers (blue and violet line) have such a value that is acceptable. Third turbocharger at first test had very high value of amplitude (red line) which enforced to stopped test and send the turbocharger to workshop to repair. After repair third turbocharger was tested again and this time results (green line) were in acceptable by manufacturer regulations zone. Very popular measuring indicator in vibro-acoustic measurements – RMS – (Figure 7) is not such effective and clear tool for diagnostics as I-st harmonic as it is seen in figure 7. In RMS mode values of vibrations amplitudes are very similar and not such recognizable as it is for I-st harmonic.

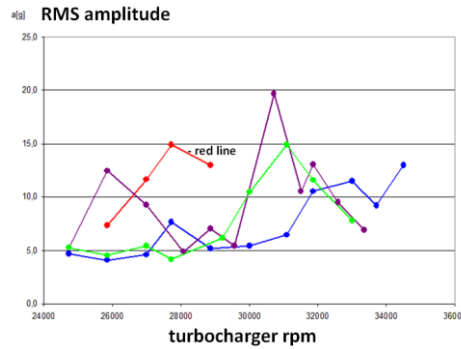
**Fig. 7.** RMS amplitudes for three turbochargers. Red line – turbocharger in bad technical condition. Blue, violet and green – turbochargers in good technical conditions

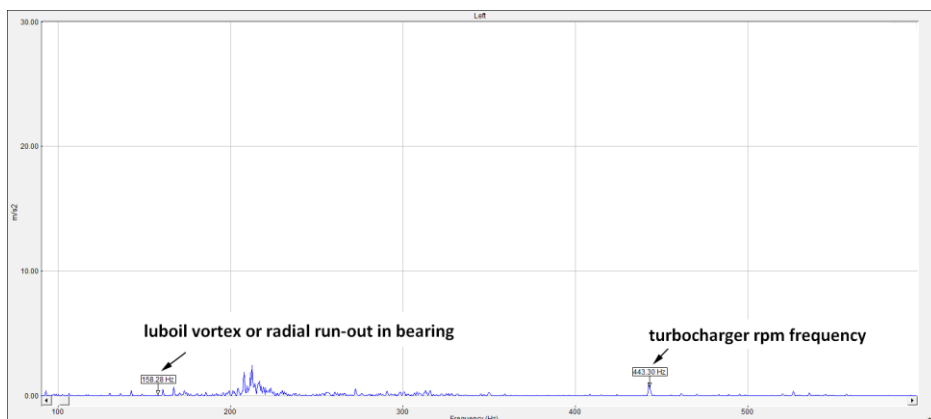
**Fig. 10.** Amplitude of vibrations accelerations in frequency domain for turbocharger in good technical conditions

The FFT signal processing is very popular tool in rotary machines diagnostics. In the fig. 10 and in the fig. 11 vibrations signals transformed into frequency domain by using FFT technique are presented. In the fig. 10 the vibration signals in frequency domain for turbocharger in good technical conditions is presented. In the fig. 11 for this same turbocharger in bad technical conditions

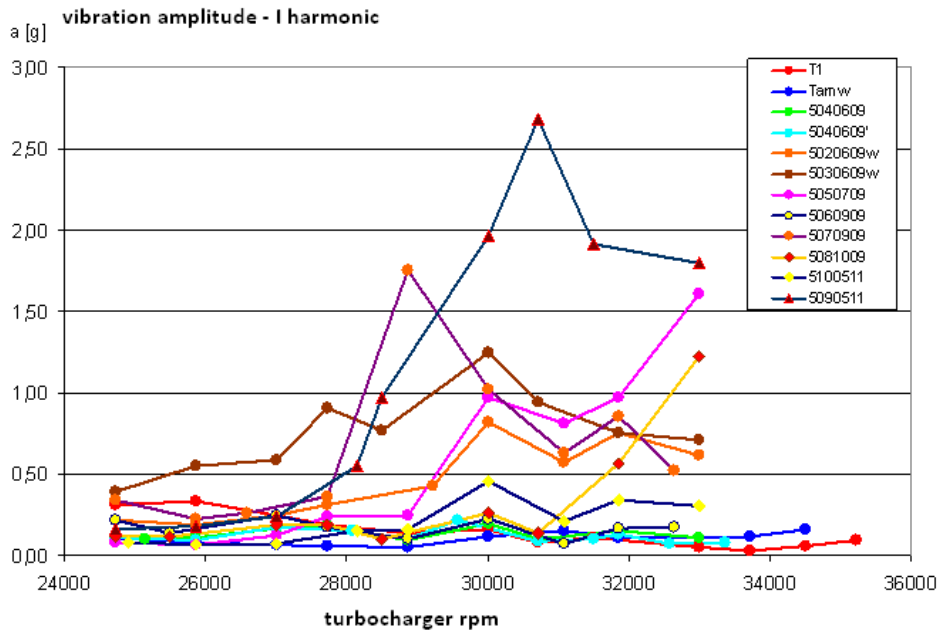
**Fig. 12.** Vibrations acceleration amplitude – I harmonic measured on turbocharger bearing casing versus turbocharger rpm – twelve turbochargers in different technical conditions tested on the same marine diesel engine stand

During the research done in PNA connected with turbochargers technical conditions assessment several turbochargers were tested. In the figure no 12 one of chosen results of these tests are presented. The 1-st harmonic for twelve turbochargers tested on the same diesel engine stand varies from less than 0,50 [g] to more than 2,5 [g] in one cases. Only turbochargers with this parameter value below 1[g] were accepted by classification societies to use on ships and stationary power plants. Much more reliable in operation are off course these turbochargers which are in lower region of acceptable vibrations amplitude zone.
